Mobile Pentium® II Processor Specification Update

Release Date: July 1999

Order Number: 243887-012

The Mobile Pentium® II processor or the Intel® Pentium® II Processor Mobile Module may contain design defects or errors known as errata which may cause the product to deviate from published specifications. Current characterized errata are documented in this Specification Update.

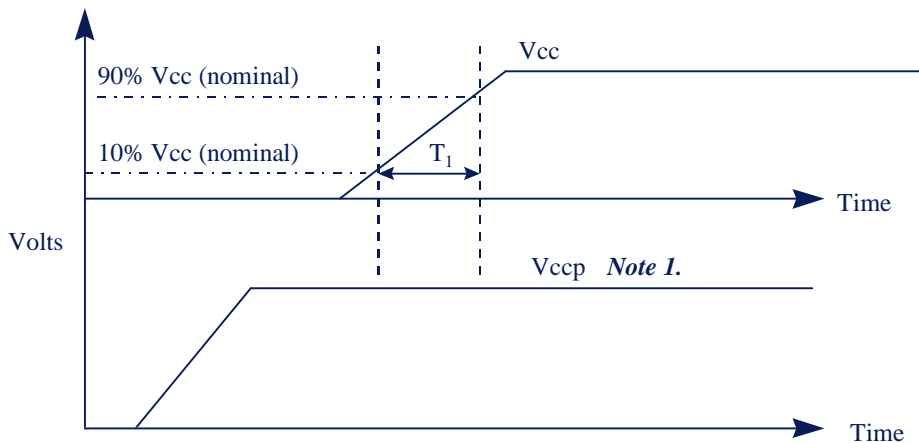
Figure 1. V_{CC}/V_{CCP} Timing Requirements (Mobile)

PROBLEM: The processor uses the PWRGOOD signal to ensure that no voltage sequencing issues arise; no pin assertions should cause the processor to change its behavior until this signal is asserted, when all power supplies and clocks to the processor are valid and stable. However, if V_{CC} ramps up before V_{CCP} , it will cause the processor to enter an invalid state.

IMPLICATION: If this erratum occurs, the system may boot normally however, the L2 cache may not be initialized.

WORKAROUND: For Mobile Pentium II processors, ensure that V_{CC} ramps after or with the L2 cache IO voltage (V_{CCP}). If V_{CCP} ramps after the V_{CC} , a delay circuit can be placed on the core V_{CC} to ensure that V_{CC} ramps at the same time or after V_{CCP} as shown below in Figure 1.

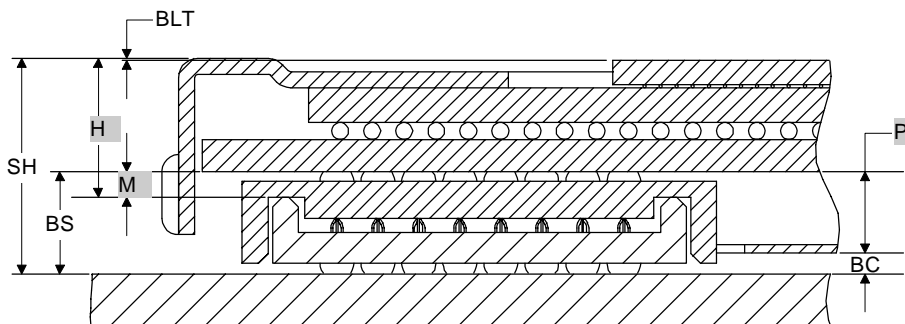
Figure 5.6. Cross Sectional View with Vertical Dimensions

B1. Misabeled Vertical Dimension Parameters

Figure 5.6 in the *Mobile Pentium® II Processor at 233 MHz, 266 MHz, and 300 MHz* datasheet should be replaced by the following figure:

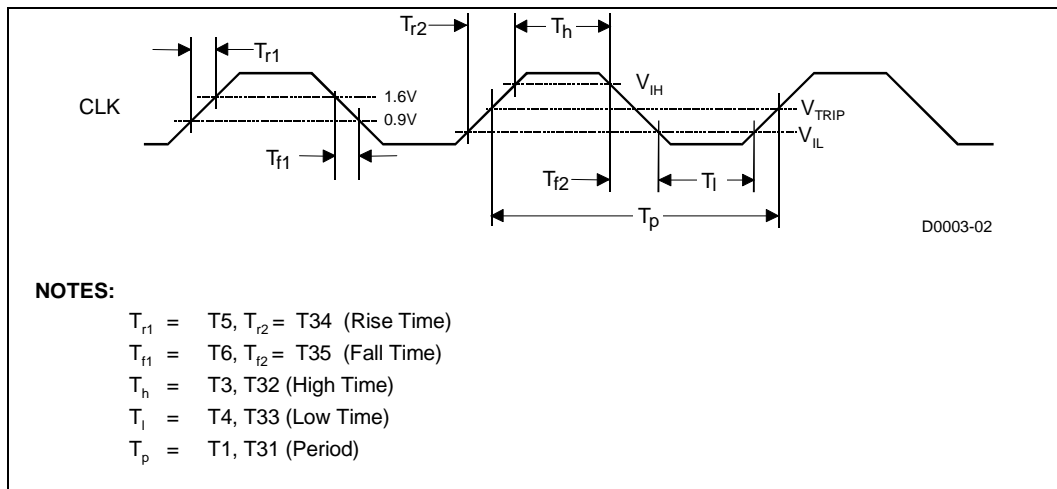
Figure 3.3 Generic Clock Waveform

B14. Generic Clock Waveform Figure

Figure 3.3 in *Mobile Pentium® II Processor in Mini-Cartridge Package at 366 MHz, 333 MHz, 300PE MHz, and 266PE MHz* datasheet (Order Number 245108), and the *Mobile Pentium® II Processor in BGA Package at 366 MHz, 333 MHz, 300PE MHz, and 266PE MHz* datasheet (Order Number 245106) has been updated. The following figure is to replace the ones in the above documents.

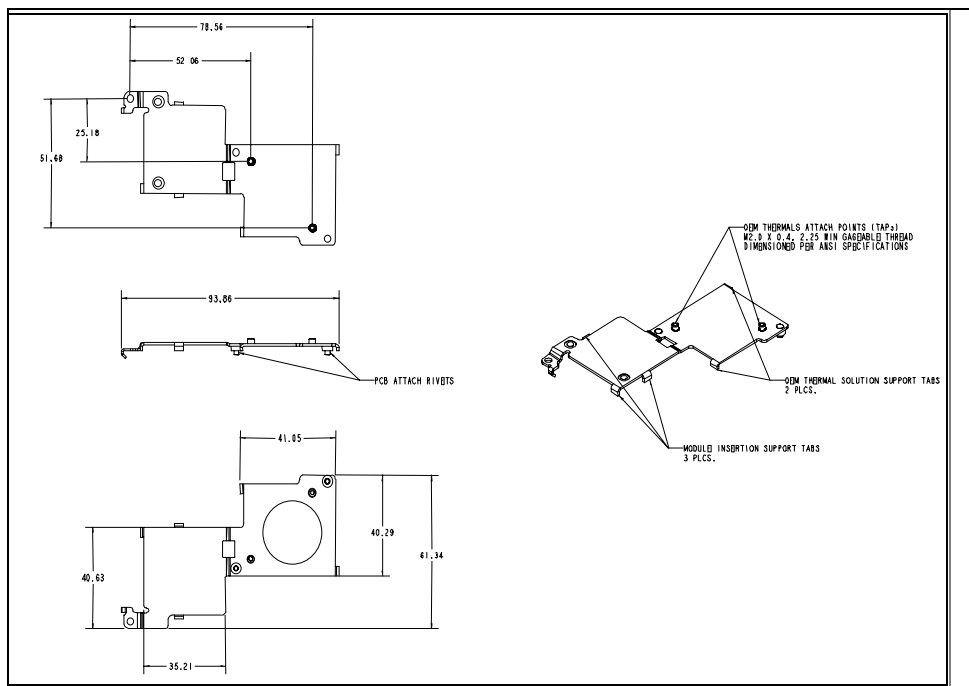
Figure 1. TAP Gageable Thread Clarification

OEM Thermal Attach Points (TAPs) M2.0 x 0.4, 2.25 min gageable thread dimensioned per ANSI specification.
